## CONTROL OF WELL KS-8 IN THE KILAUEA LOWER EAST RIFT ZONE

Bill Rickard (Resource Group), B.J. Livesay (Livesay, Inc.), Bill Teplow (Trans-Pacific Geothermal Corp.), Steve Winters (CUDD Pressure Control), Jerry Evanoff (Halliburton Energy Services), and W.T. Howard (GeothermEx)

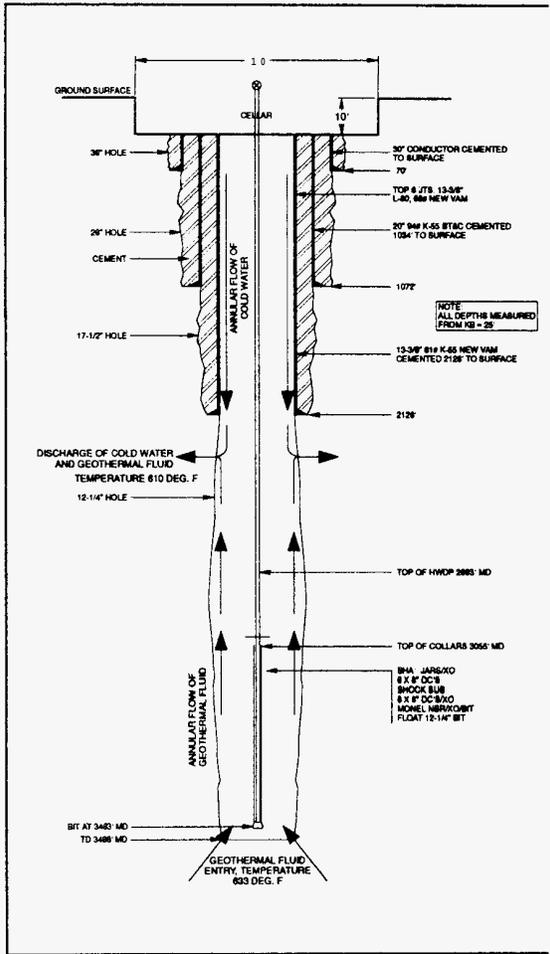
Figure 1 - Well conditions, 23 June 1991.

On June 12, cement was drilled out of the 12 1/4-in. (31.12-cm) hole from 3,350 ft (1,021 m) to 3,400 ft (1,036 m). As the driller continued to drill new formation from 3,400 ft (1,036 m) to 3,476 ft (1,059 m), he observed a 2-ft drilling break with an almost instantaneous rate of penetration. He was picking up on the Kelly to close the BOP equipment when the well unloaded and blew him off the brake.

The annular BOP failed, and the 5-in. pipe rams were closed around the 6-in. hexagonal Kelly. A 4-in. choke bypass line was opened to divert as much flow as possible away from the rig floor.

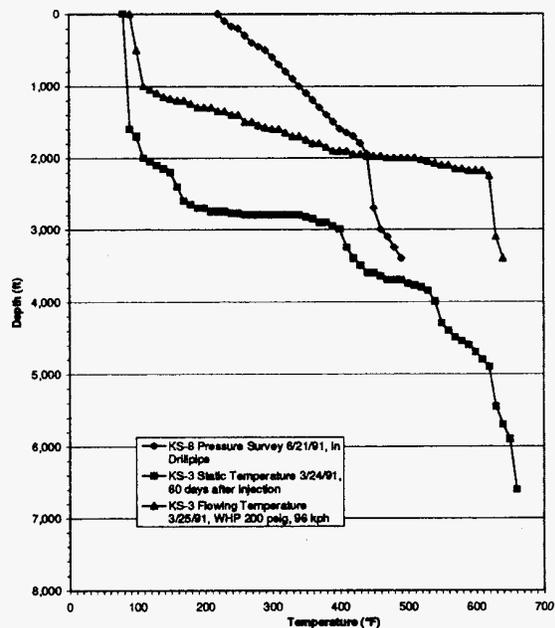
Figure 2—KS-3 Static Temperature, KS-8 Static Temperature and pressure Profiles.

Temperature surveys run on July 15 showed a temperature increase at 1,650 ft (503 m). The temperature at 2,100 ft (640 m) was 340°F (171°C). Temperature at 3,124 ft (952 m) was 475°F (246°C). The temperature survey results indicated that a crossflow existed at 2,128 ft (649 m) at the 13 3/8-in. (33.97-cm) casing shoe (Fig. 1). Temperature surveys on June 21 indicated a maximum bottomhole temperature of 633°F (334°C). When pressure/temperature surveys were attempted on June 26, the survey was terminated at 1,800 ft (549 m) because of increased pressure on the drillpipe. Attempts to plug off the upper thief zone with LCM pills were unsuccessful (Fig. 2).

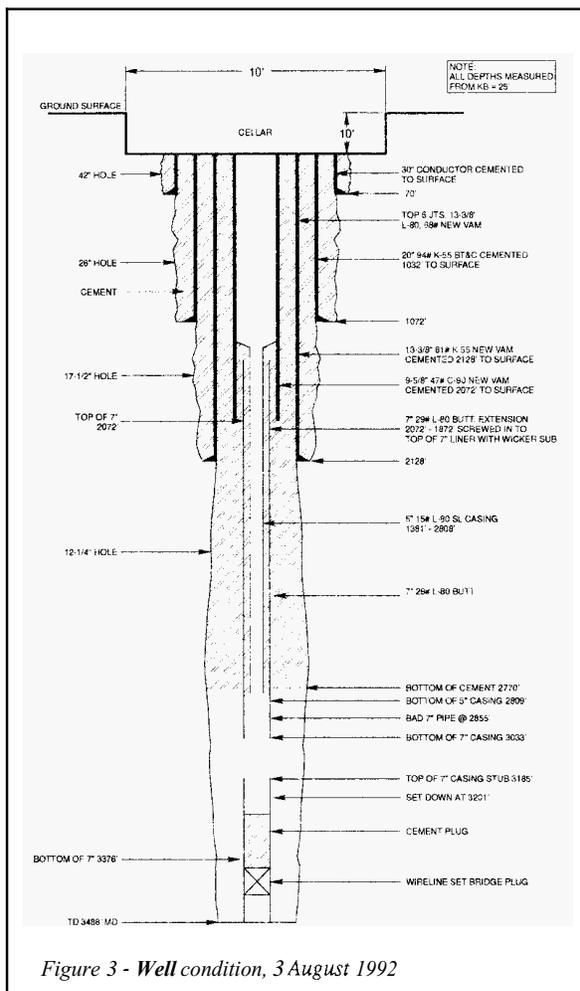
Subsequently, a 5-in. (12.7-cm) liner was cemented inside the 7-in. (17.78-cm) casing to cover damaged sections (Fig. 3). The 7-in. (17.78-cm) casing was damaged when it was cooled during completion operations. All operations after the plug was drilled out of the 7-in. (17.78-cm) casing were performed using the 450 rig-assist snubbing unit. The well was placed on line to the power plant and produced over 12 MWe during power plant startup.
