## Maintenance History of a Geothermal Plant: Svartsengi Iceland

Geir Thorolfsson

Hitaveita Sudurnesja, Brekkustígur 36, 260, Njardvik, Iceland>

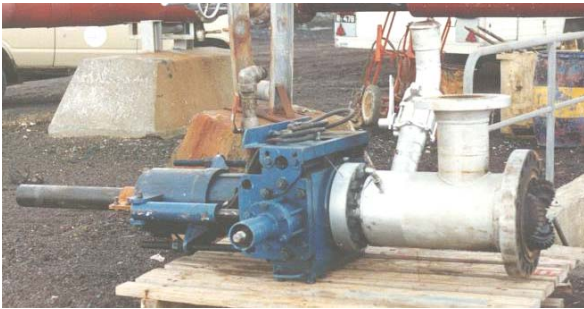
In the early years of operation, calcite scaling used to form in the boiling zone at 500 to 600 m depth. The scaling had to be cleaned by drilling approximately every 2 years. Hitaveita Suðurnesja, together with Orkustofnun (now ISOR) and Jarðboranir (Iceland Drilling Company), devised a drilling method which made it possible to drill out the scaling while the well was kept flowing and the debris was brought to the surface. The workover is done with the well flowing, by using a drilling rig with a top drive and flush coupling drill pipes. The wellhead has a stuffing box and a water-cooled spool piece flow diverter.

**Figure 4:** From left: Stuffing box, BOP, spool-piece, and drill bit.

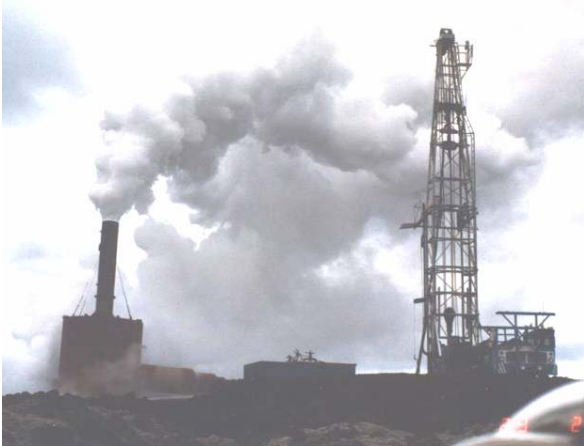
**Figure 5:** Workover showing rig and silencer.

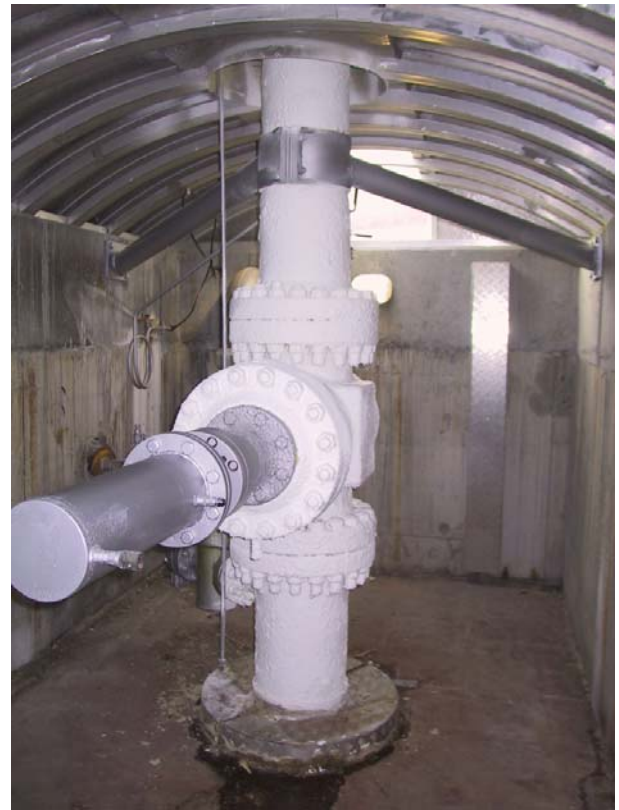
The master valves on the wellheads have to be extremely reliable but have required more maintenance than originally expected. It is gate valve type with expanding gate. Pitting corrosion of valve stems made of both 13 % Cr steel and hard chromed steel has been serious. Changing stem material to SAF 2205 duplex and 17- 4 PH stainless steel have eliminated the pitting corrosion problem. Stem handwheel thrust bearings used to fail after only a few operations of the valves. The valves have been modified to be operated by a hydraulic jack powered by a portable diesel-driven hydraulic pump or a stationary electric pump.

**Figure 6:** Wellhead master valve with hydraulic jack and spray on insulation.

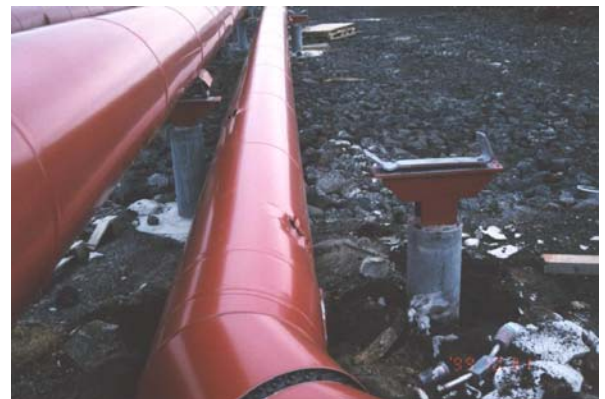
Slug flow sometimes occurs in two-phase-flow pipelines. Two-phase pipelines from boreholes are generally without problems, unless they slope upwards or have long horizontal runs. Slug flow has knocked pipes off their supports as can be seen in Figure 7. Methods to keep the pipes free from slugs while negotiating for an upwards sloping grade are being investigated and tested.

**Figure 7:** Slug flow knocked the pipe off its supports.

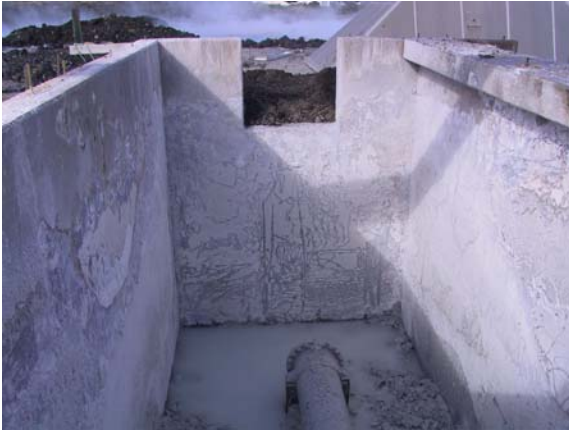
Flashing brine makes a lot of noise when it is vented directly to the atmosphere. Therefore various types of silencers have been used since the start up of the first power plant. The main source for flashing brine is from the level control valves of the separators. The most recent type of silencer is a water-filled basin where the brine inlet is 4 meters deep. The basin is made of high strength concrete, and the reinforcing steel is epoxy coated. Flash steam is vented through an aluminium hood extending high enough to prevent ground fog. This silencer is easy to clean with a backhoe when the hood has been detached.

**Figure 10: Silencer after cleaning. Inlet pipe can be seen on the bottom.**

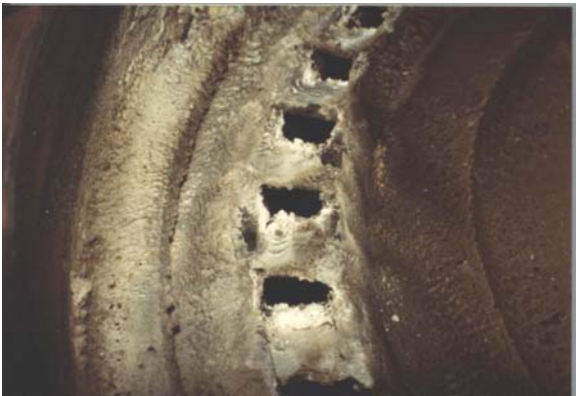
Steam turbines have to be dismantled every year to clean the scaling from the first-stage steam nozzles. The scale in the nozzles is usually silica or calcite. This nozzle scaling problem has not yet been solved adequately but some methods of steam scrubbing are being tested.

**Figure 11: Steam turbine inlet nozzles with intensive scaling.**

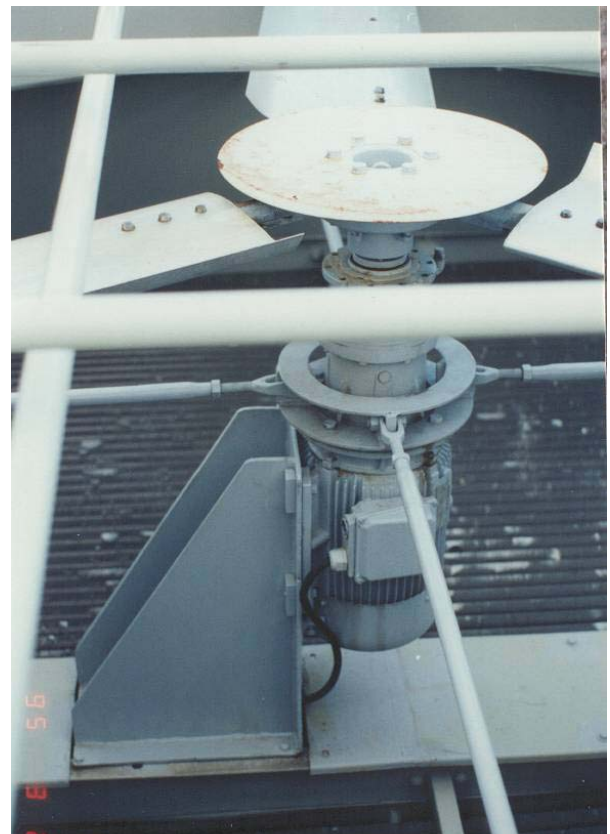
**Figure 13: ORC cooling fan with gear motor.**

The fan belts on the air cooled condensers used to snap at an alarming rate. The fan belts hardened because of hydrogen sulphide in the atmosphere and high humidity. This problem was solved by installing geared electrical motors for the fans.
